Comingled Plumes

Site: Former gas station at 3400 York Street, Denver, CO. USTs were removed in 2011 and 2012 and a new convenience store had been built in early 2013 just prior to injections.

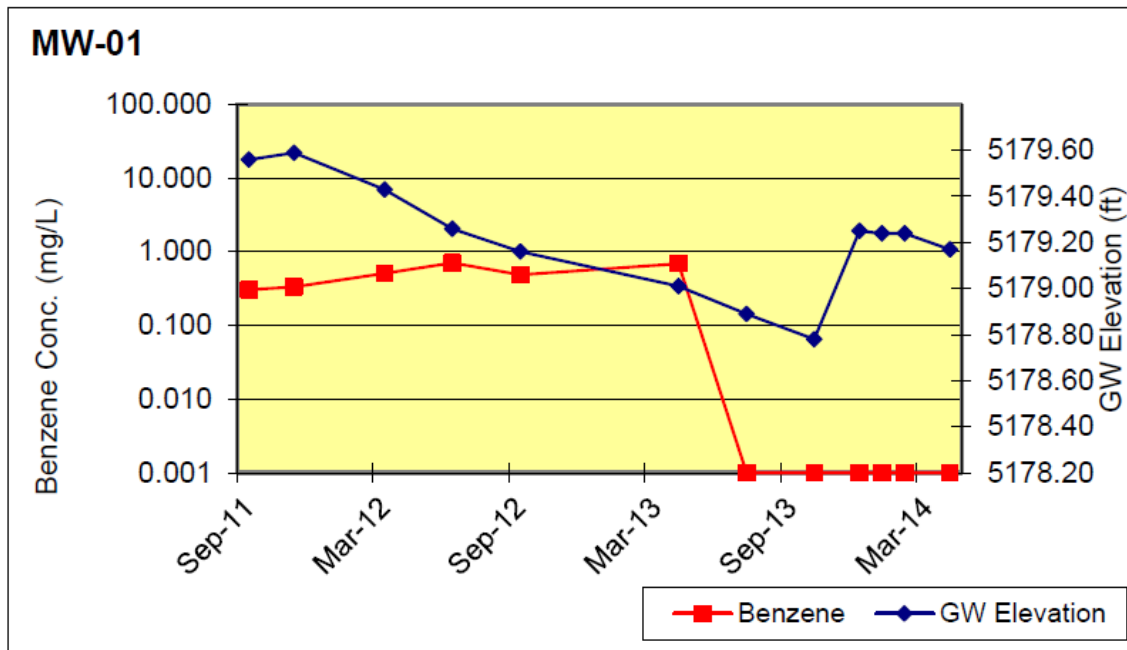
Trend Graph

Results: The client notes that "The data shows that the BOS 200® injections worked very well, even on the chlorinated solvents [comingling from an upgradient dry cleaner source.]" An NFA will be requested in 2015 once post-injection monitoring requirements have been fulfilled.

RPI Results for MW-01 Pre and Post Injections

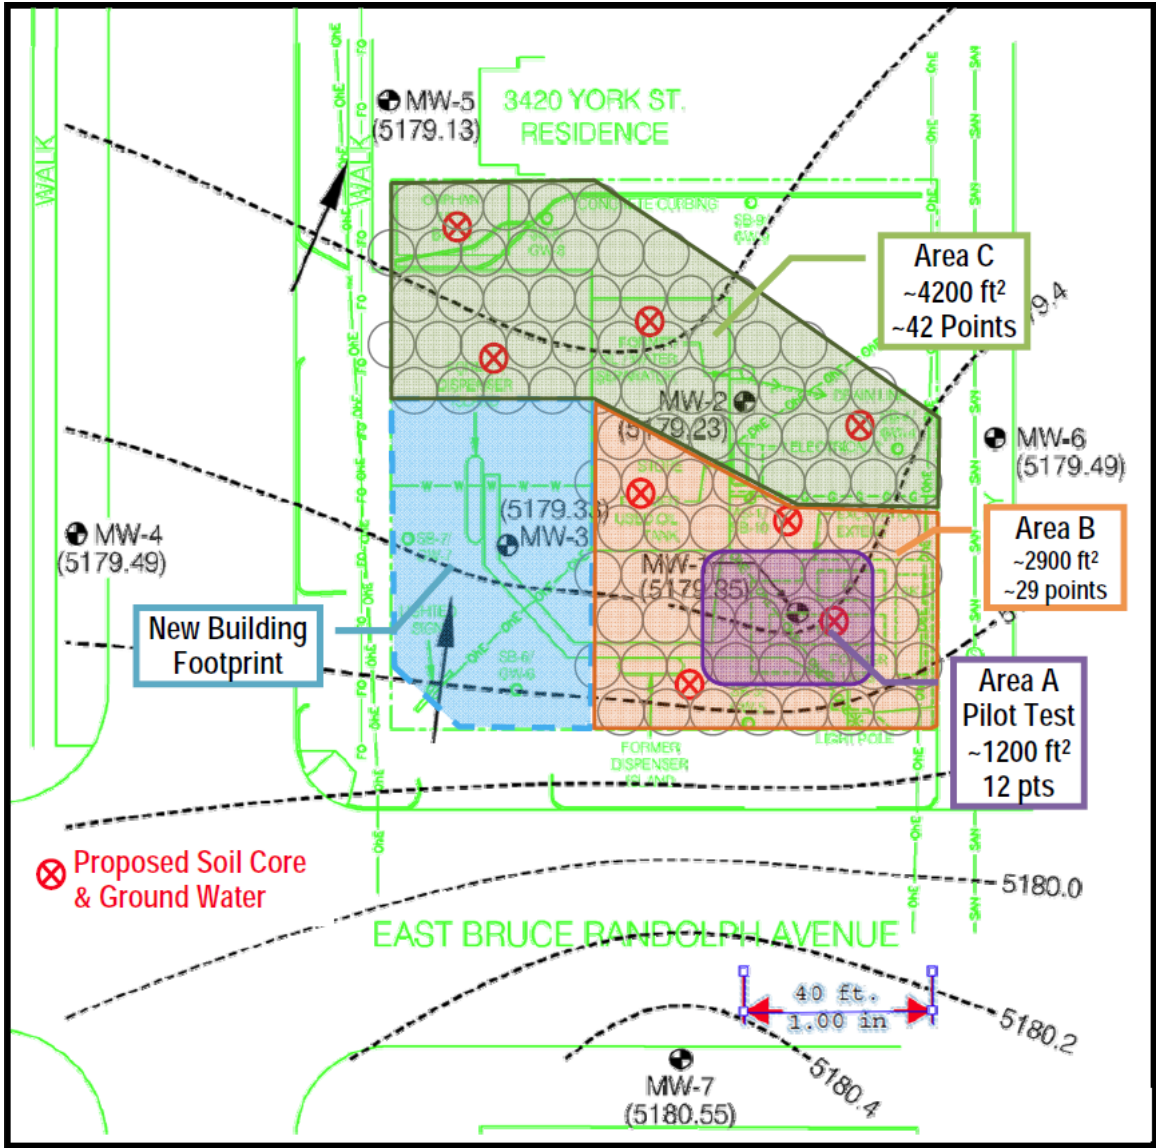
Injection Plan

Based on the positive results of the pilot test, CGRS recommended full-scale implementation of injections of BOS 200®. CGRS oversaw the full-scale injection of BOS 200® between November 18 and 21, 2013 by Vista GeoScience. Approximately 4,625 pounds of BOS 200® were injected at staggered 2-foot injection intervals that ranged from 40 to 48 feet bgs or 41 to 49 feet bgs.

BOS 200® Treatment: Vista GeoScience conducted a BOS 200® injection pilot test near source well MW-1R in May 2013. 1800 pounds of BOS 200® were injected into 12 locations around MW-01R between 40-49' at staggered 2' intervals. Injection pilot test data demonstrated that BOS 200® could be injected into the subsurface soil at the site and post injection groundwater sampling indicated significant reductions to BTEX and chlorinated solvent concentrations in groundwater samples collected from well MW-1R.
