RE: Summary Report for BOS 200® Injection at the former Kenwood BP site at 6903 Southside Drive Louisville, Kentucky (KY-USTB- A.I. #60708)

AST Environmental, Inc. (AST) appreciates the opportunity to have provided the injection services at the above referenced site. This letter report provides a summary of the BOS 200® injection activities conducted on February 12th 2013.

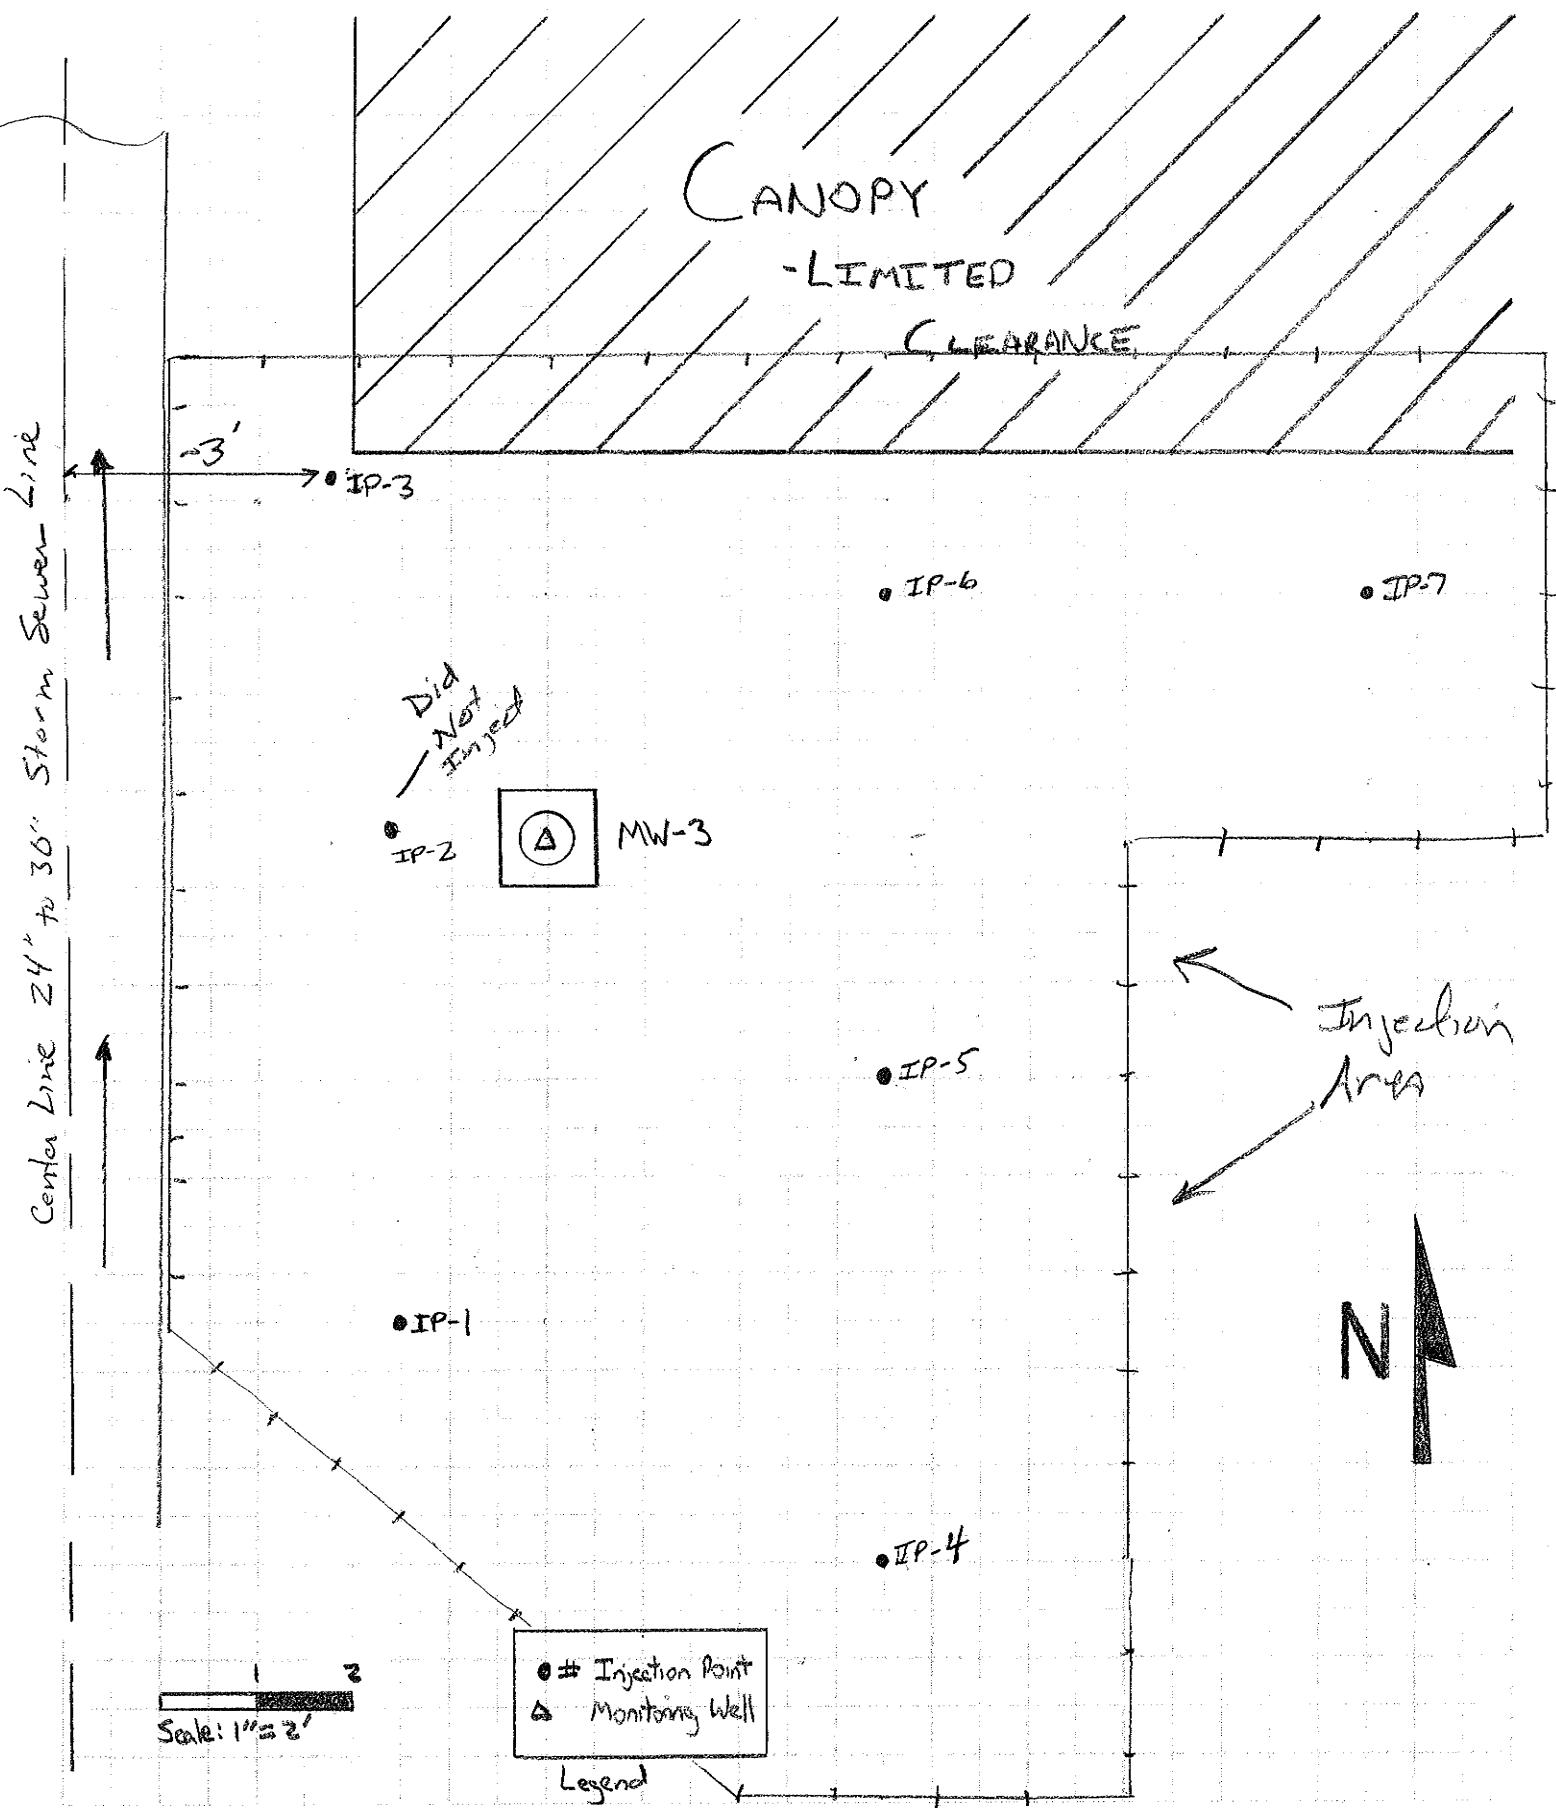
This was due to limited overhead clearance from the existing canopy in the northern portion of the injection area and the location of a 24" to 30" storm sewer line that ran through the western portion of the injection area. The layout was changed from 15 points on 3.5' centers to seven (7) points on 5' centers to accommodate these appurtenances. The area was reconfigured as an L-shape. Figure 1 identifies the revised injection area.

During the injection effort it was necessary to adjust the loadings to a 2.5 lb of BOS 200®/gallon of prepared slurry and reduce shot volumes to minimize excessive daylighting from within and around MW-3 well casing. As shown on Figure 1, seven (7) injection points were laid out, but BOS 200® was only installed in six of these. Injection point was not injected as all injection points significantly influenced MW-3 with the exception of IP-1. During injection at IP-1, BOS 200® daylighted in an existing asphalt crack.

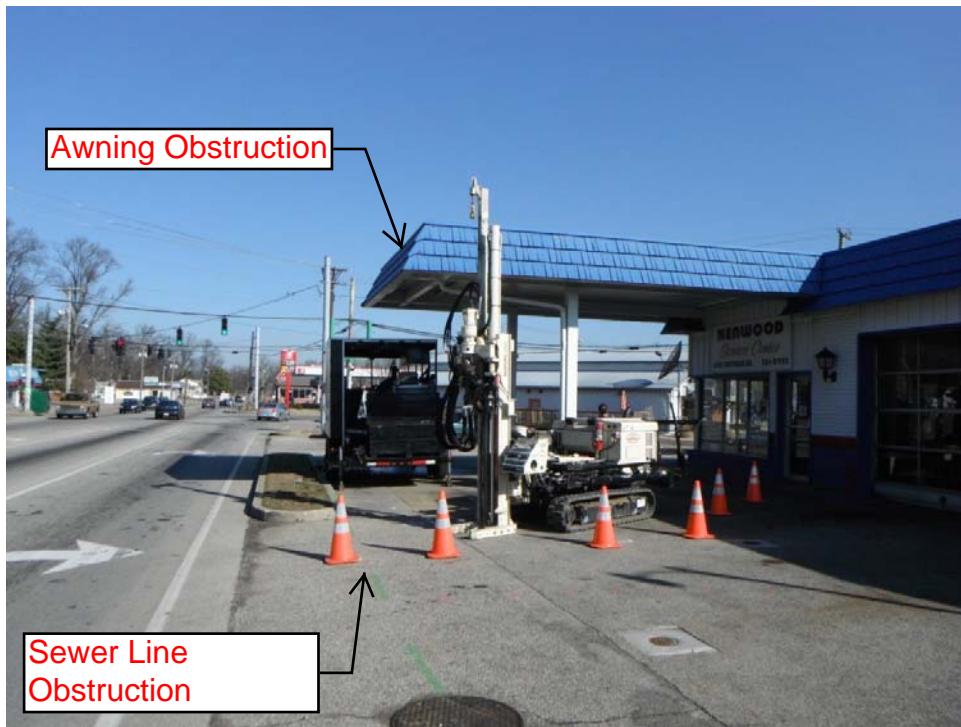
Photo 1 – Driving to inject, Geoprobe® in foreground and injection trailer in background.
02/12/13

On the morning of the February 12, 2013, AST mobilized personnel and equipment to the site and setup for the injection effort to begin that day. The attached photographic documentation shows the mixing and injection system, power probe and generator needed for the injection effort.

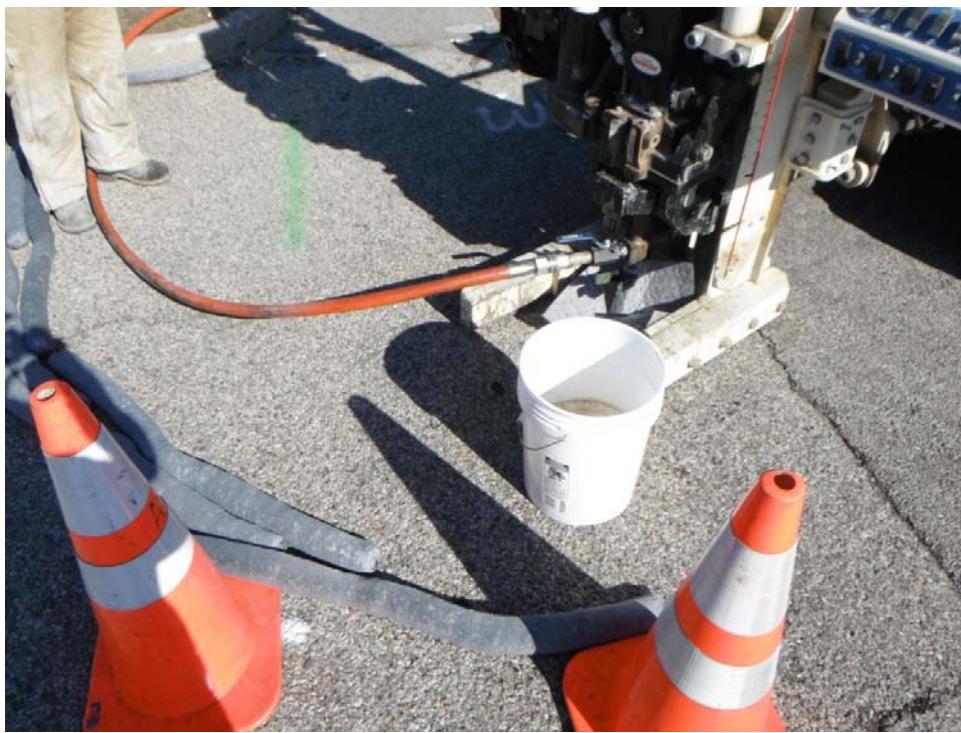
Photo 2 – Injecting Point 3. 02/12/13

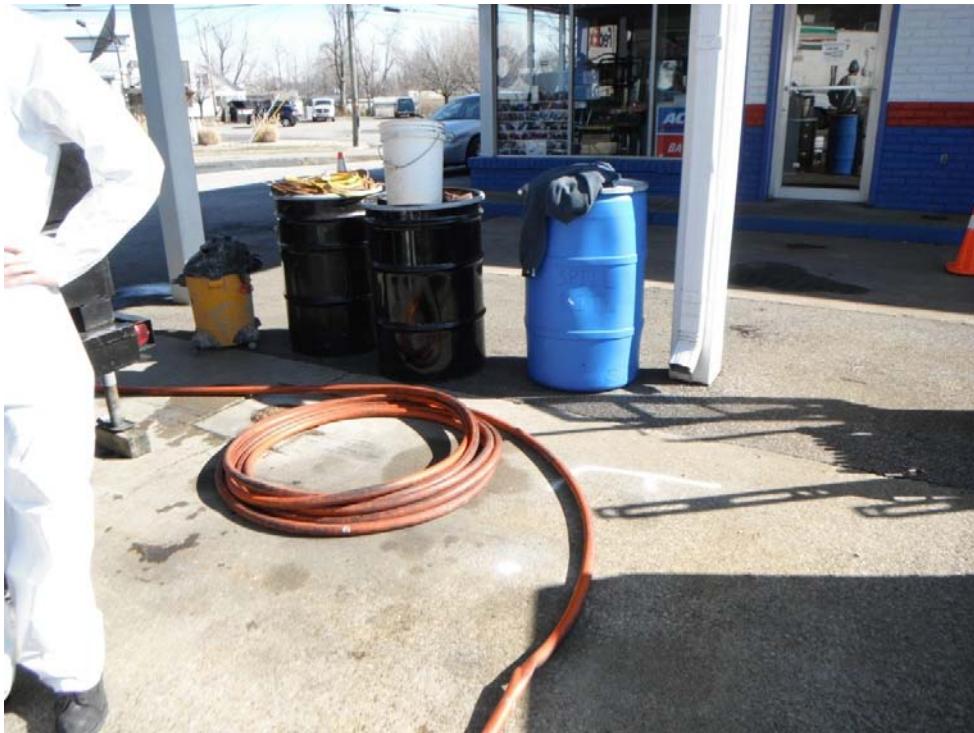
Photo 3 – Spill kit and clean-up supplies. 02/12/13

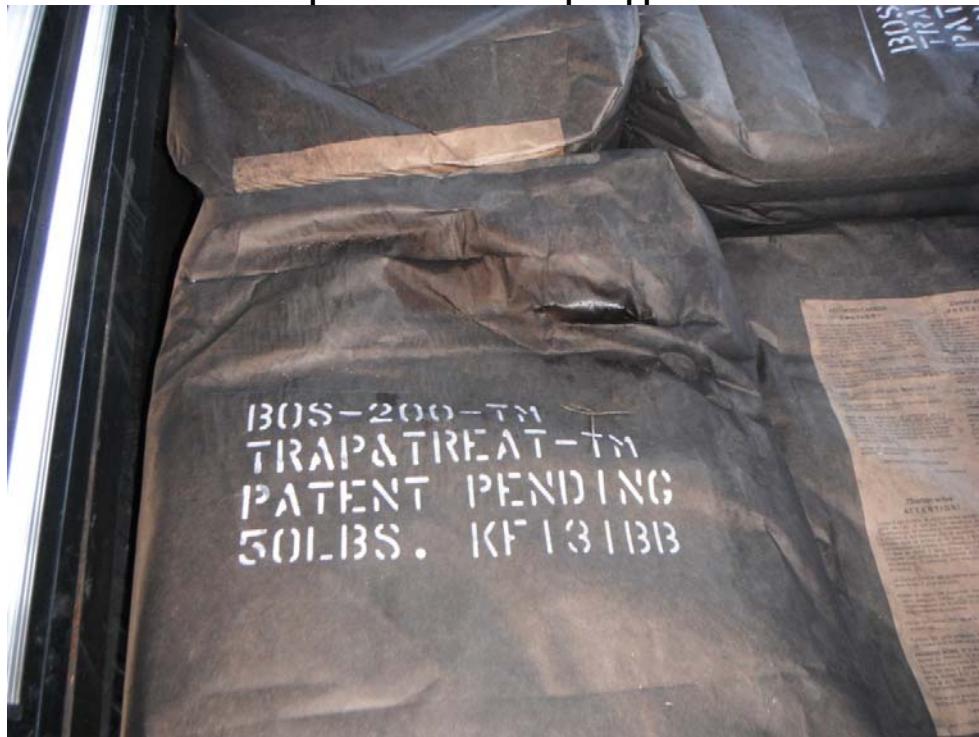
Photo 4 – BOS 200® material to be injected. 02/12/13
