# BOS 200® APPLICATION AT AN ACTIVE GAS STATION

Trap and Treat® BOS 200® was applied at an active gas station in Europe with elevated dissolved phase contamination and NAPL impacts to protect the primary aquifer and cut off the dissolved phase plume from migrating off site. Over the course of 4.5 years of monitoring, 92.4-99.9% reductions in Benzene were achieved in the treatment area (replaced) monitoring wells. Validation soil samples collected 36 months post injection indicate clear evidence of total mass reduction.

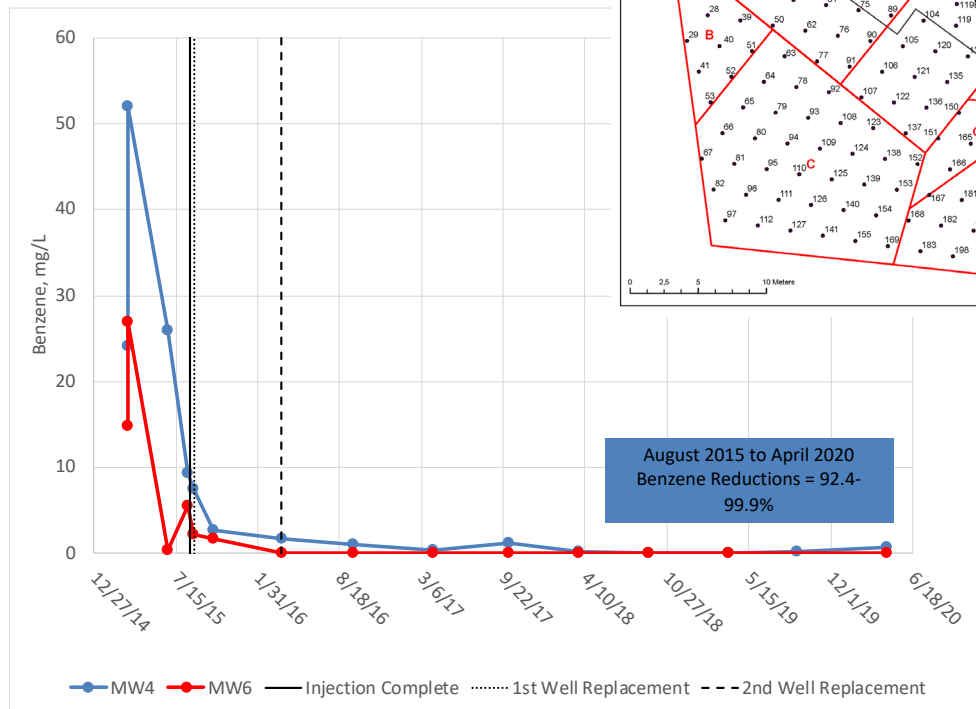
Figure 2. Key Monitoring Well Benzene Concentrations v. Time

- Three monitoring wells within the remediation zone were demolished during the construction of the new parking lot. Due to site regrading, the first set of replacement wells were reinstalled about 6 months after the initial re-installation (Figure 2). Benzene concentrations in the replacement wells have been reduced 92.4-9-99.9% over the 4.5-year monitoring period.

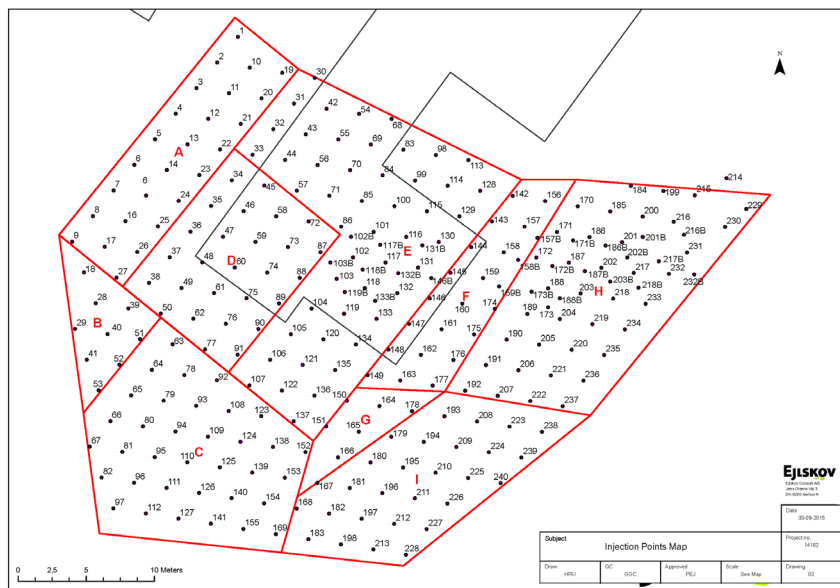
Figure 1. Site Map with Surgical Injection Design

- Based upon the MIP and RDC data, a 3D model was created to develop a surgical injection design (Figure 1).
- Later in 2015, BOS 200® was installed via direct push injection into 267 injection locations (2.3 m spacing) between 4 and 13 m bls. Approximately 43,000 kg of BOS 200® and 22,500 kg of supplemental gypsum (additional sulfate source) were applied during the remedial effort.

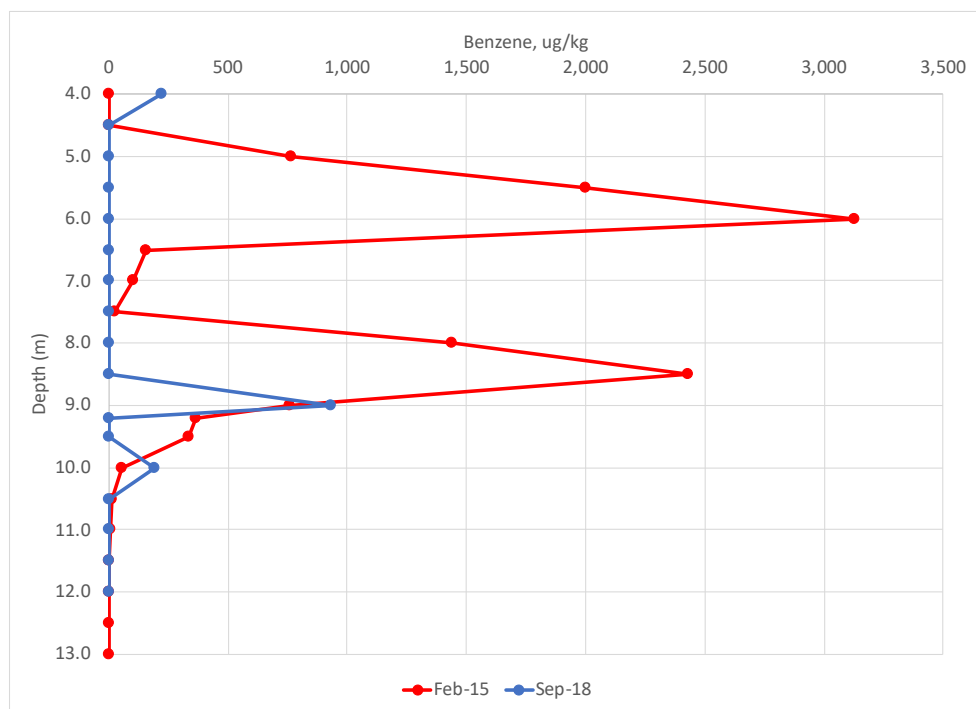
Figure 3. Pre and Post Remediation Benzene Concentrations in Soil

- Validation soil samples were collected three years post injection to assess adsorbed mass concentration changes (Figure 3). In general, significant reductions were observed in the three borings advanced adjacent to RDC locations. Data from thirty-seven soil samples were compared to pre-injection data. Reductions were observed in thirty-three samples, increases were observed in two samples, and no concentration changes were observed in two samples.
